An Innovative Restoration Project in the Upper St. Johns River Basin

Dean R. Dobberfuhl

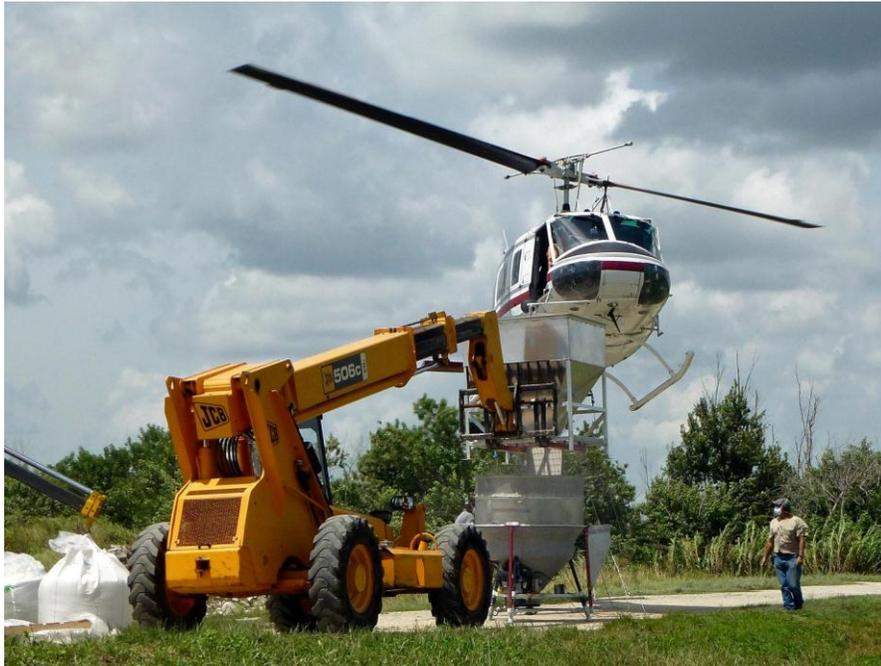
Figure 3. Loading a 909 kg bag of alum into the calibrated application bucket. The helicopter hovered over the bucket while it was being loaded!

In the third part of the plan, a chemical amendment--alum (Al_2SO_4) in this case-- was applied to bind bioavailable P in the sediments. Alum dosage was based on measured bioavailable phosphorus in the sediments. The innovative aspect of this alum application was that we applied a solid granular alum product. Granular alum was chosen so that it would readily fall through any standing vegetation rather than adhere as liquid alum would. We also chose granular alum to ensure that the material would settle rapidly through the water column (≈ 60 cm) to minimize interaction with water column constituents and remain maximally effective in capping the sediments. In August 2012, a contractor applied 136,078 kg of alum (≈ 5 mm grain size) over 243 ha using a helicopter with a metered bucket (Figs. 3-5). The application required approximately 150 trips with a turnaround time of 6-10 minutes. Minimal floc formation was observed shortly after the alum hit the water.

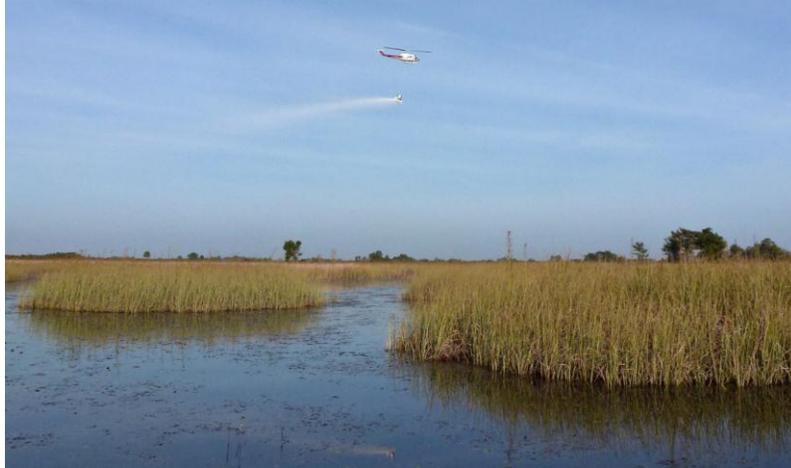
Figure 4. The helicopter applying alum over the treated marsh (in the distance) with a view of the desired condition in the foreground.

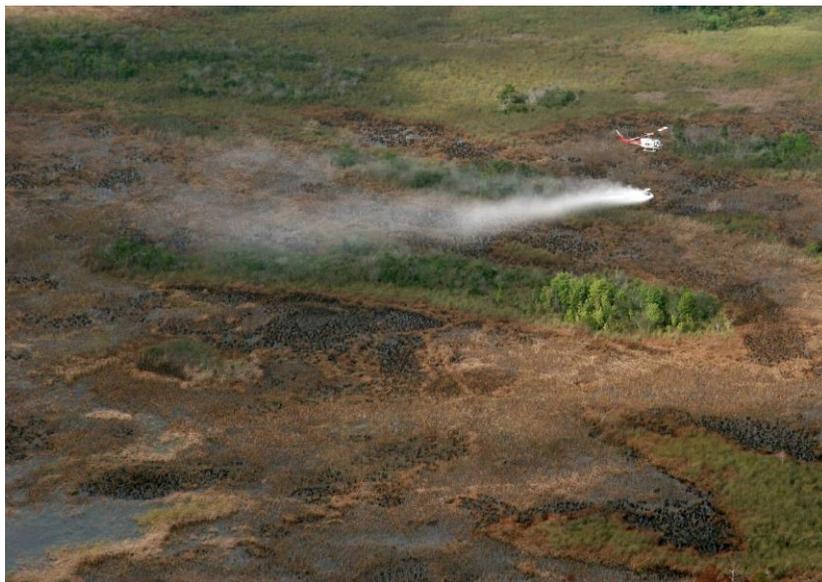
Figure 5. Alum application over the burned area of Ansin West.
